## Improvement in Flood Resilience from the use of Stormdry

The objective of this piece of work was to determine the extent of flood resilience improvement from the application of Stormdry.

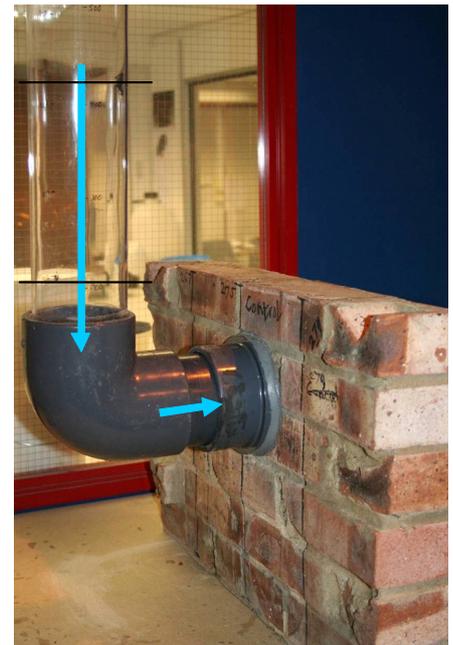
Photo 1: Experimental set-up

A large scale water pressure tube was constructed to simulate a flood situation as shown in Photo 1. This was built from 12 cm diameter drainage tubing and clear polycarbonate. The tube was then attached to the surface of the wall using a water proof sealant.

The test was started by quickly pouring in water into the tube to a height of 0.6 metres. The flow of water through the wall was then measured by monitoring the reduction in height of the head of water. A series of photographs were taken to record the observations.

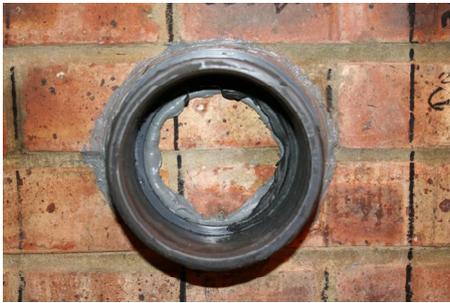
A 100mm diameter tube was attached to a brick wall (Flettons with brick-laying mortar 5:1 sand:cement)

A clear plastic pipe was attached. Water was filled to a height of 0.6m

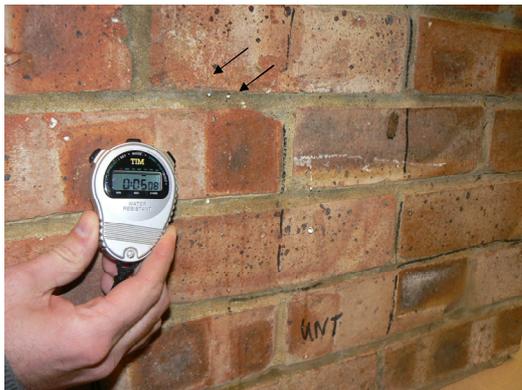
Water penetrates through the wall in a few seconds

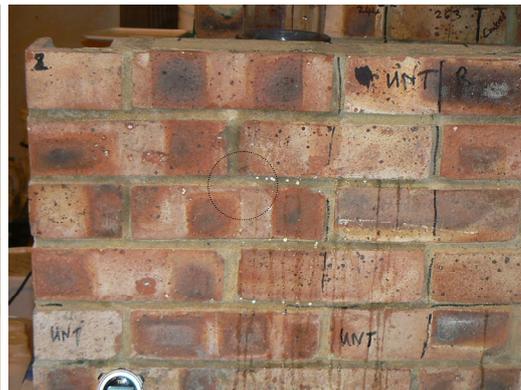
After a few minutes, leaks spread into new areas away from where the pipe was.

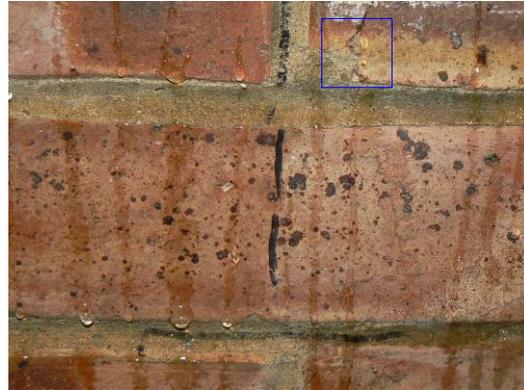
Although the joint looks sound, water penetrates at the lower brick-mortar interface. This is the weak **point** as this is a flat interface at the bottom of the brick (no frog)

Water also penetrates through cracks in the bricks

The work has shown that water penetrates very quickly through a 4" standard Fletton brick wall. The predominant flow appears to be through the brick and mortar interface, especially at the straight joint at the lower face of the brick. There was less evidence of water flow through the frogged joint which has a more complex profile and would be expected to be the more robust of the two joints.

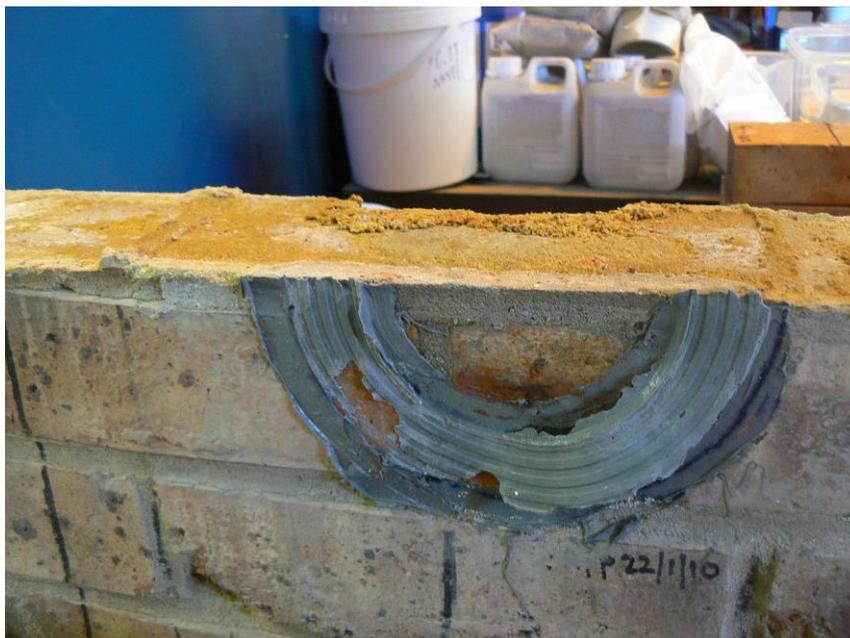
View of wall and repointing after dismantling at the end of the test

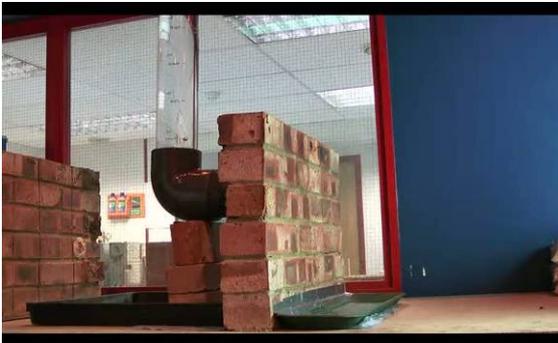
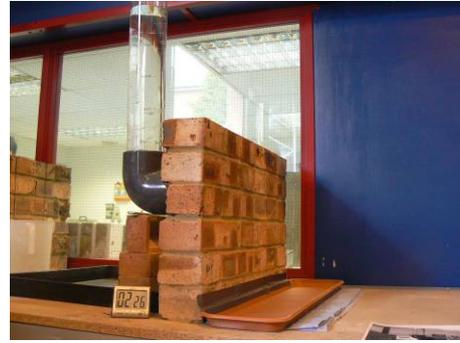
1 min

Appendix 2: Comparison between Treated and Untreated at Different Test Times

Untreated

Treated
